Reference project

## Comprex® cleaning of a cooling system with absorber in the energy center of an exhibition center

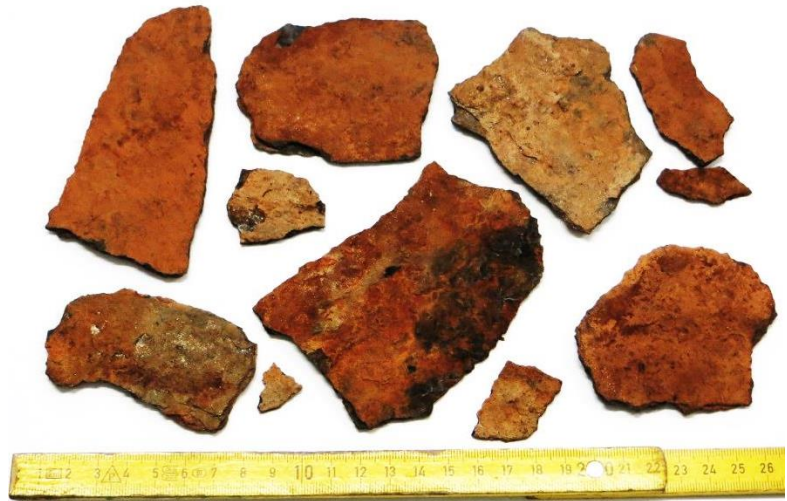
Figure 1: deposits removed from the system

- remove deposits (Figure 1) from the system
- clean an absorber (Figure 2) and feed / discharge lines of the cooling system
- recover performance, safety and reliability of the system

- deposits mobilized and discharged (Figure 1 and Figure 4)
- increased performance
- improved safety and reliability
- efficient operation

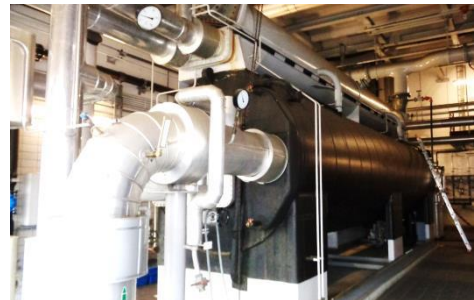
Figure 2: absorber (Shell and tube heat exchanger) in cooling center

- pipelines up to DN 400, length approx. 60 m
- absorber (shell and tube heat exchanger): length 8 m, diameter 1,6 m
- permitted pressure of system approx. 10 bar

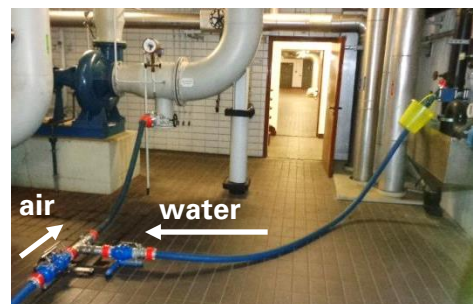
Figure 3: feed of air and water into the system

- efficient cleaning of pipelines and absorber by defined application of air and water
- access to the system via standard adapters (Figure 3)
- discharge into cooling tower pond (Figure 4)
- application of 2 Comprex® units
- 2 technicians, approx. 36 hours on site

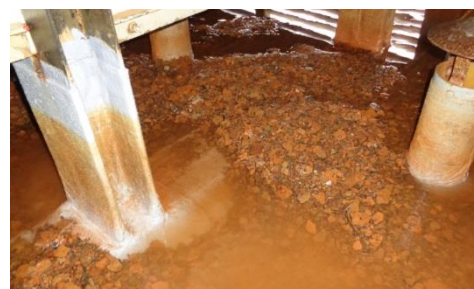
Figure 4: discharge of air, water and removed deposits into cooling tower pond
